05CA38506

Subject: 15 Minute Stay-in-Place Fire Test

On October 20, 2005, ULC conducted a 15 minute stay-in-place fire test on the AMVIC insulated concrete wall system. Testing was conducted in accordance with CAN/ULC-S101-04 and ASTM E119-00a, "Standard Test Methods for Fire Tests of Building Construction and Materials".

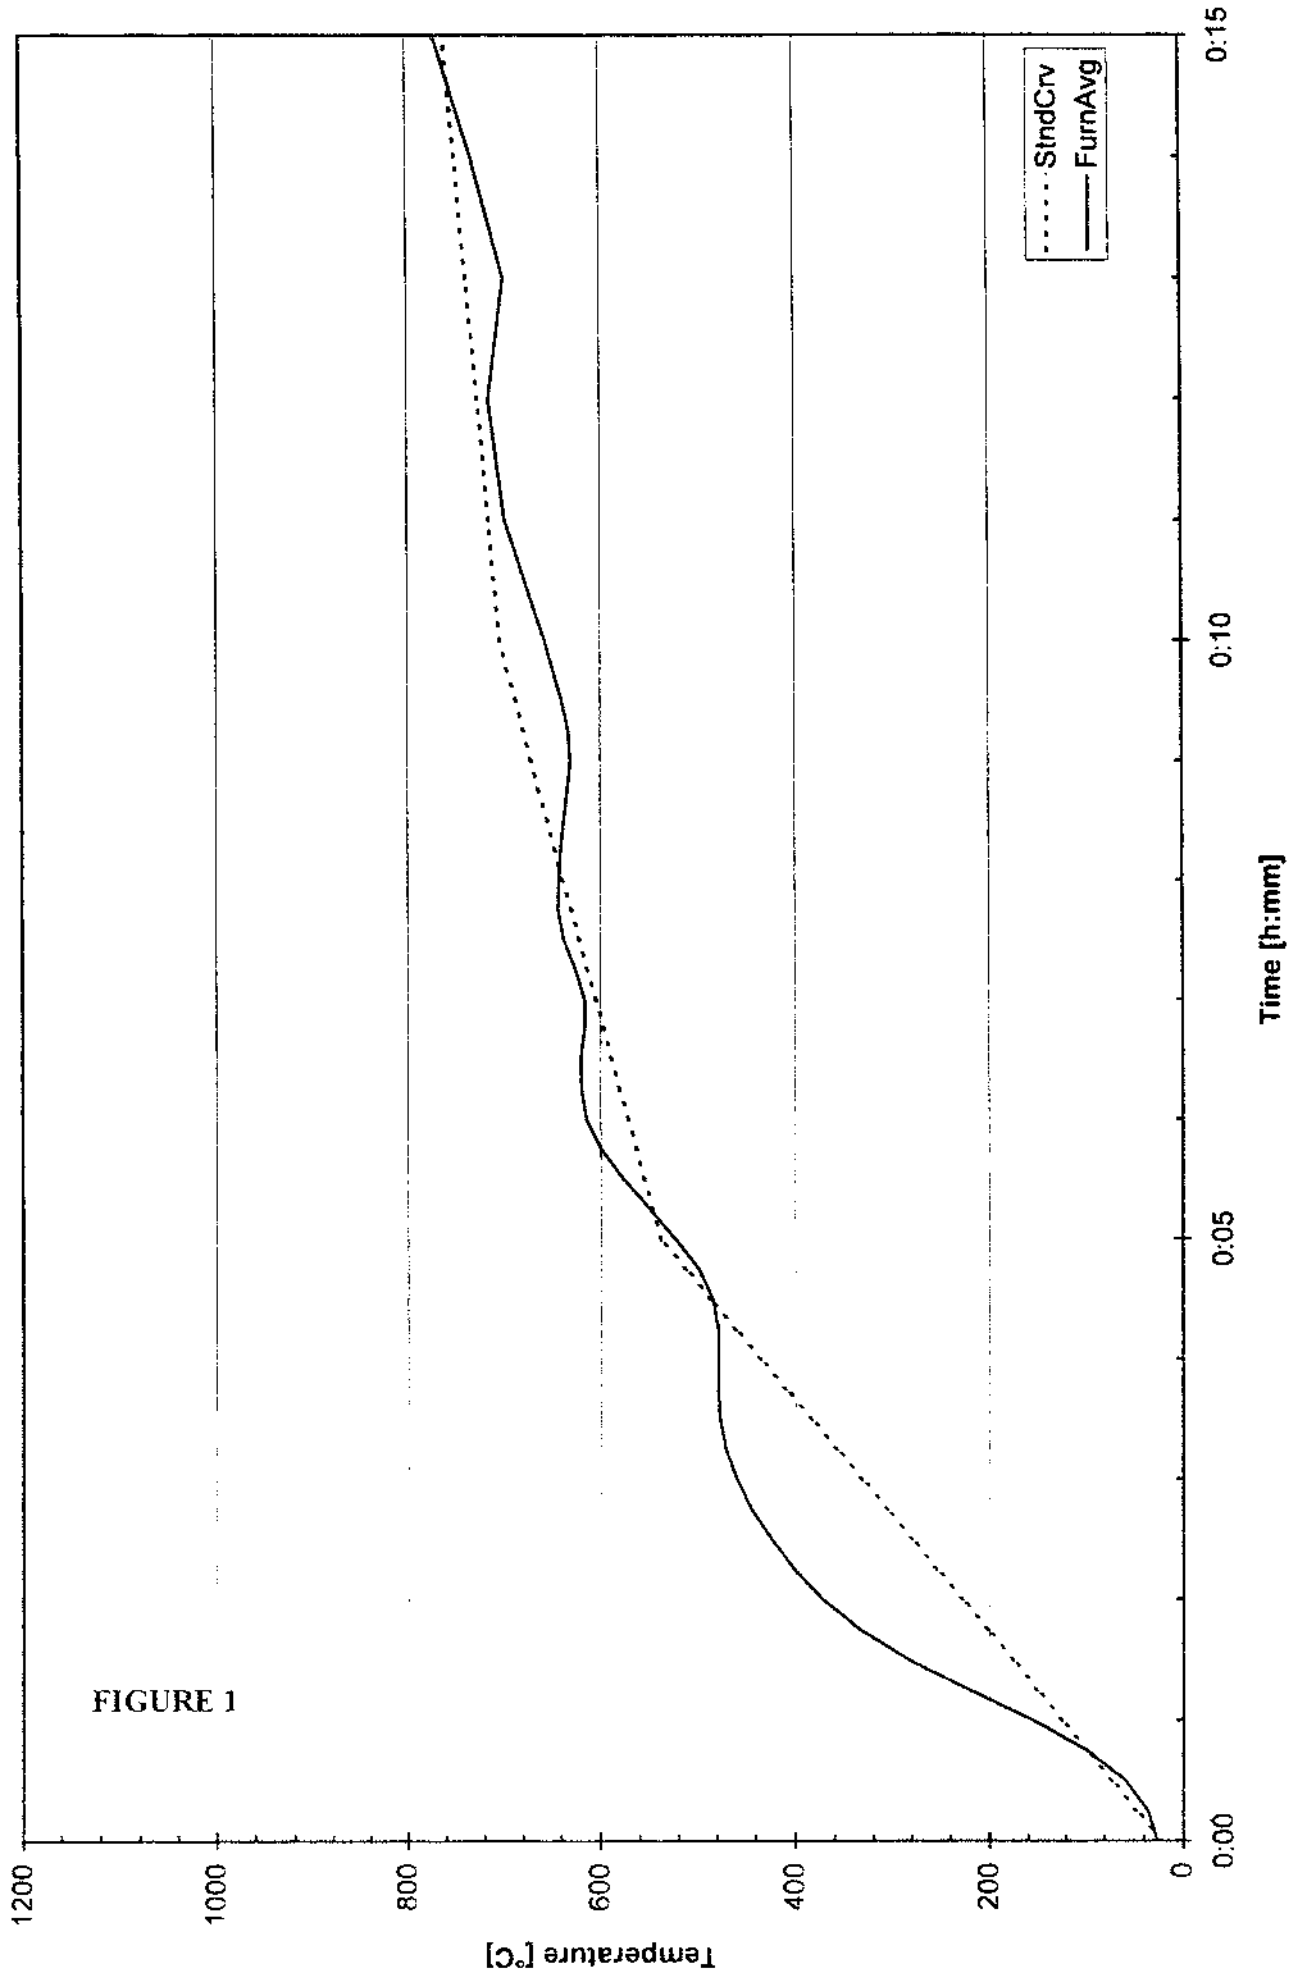
AMVIC
Furnace Time-Temperature Curve

The furnace was fired in accordance with the standard time/temperature curve contained in the standard Methods of Fire Endurance Tests of Building Construction and Materials, CAN/ULC-S101-04 and ASTM E119-00a, using a vertical panel furnace and other test equipment prescribed by the Standards. The fire in the panel furnace was luminous and well distributed. The temperatures in the furnace were monitored by twelve equally spaced thermocouples. Temperature readings were recorded every 15 seconds for the first 10 minutes of the test and every minute thereafter. See figure 1 for details. The test was continued for 15 minutes.

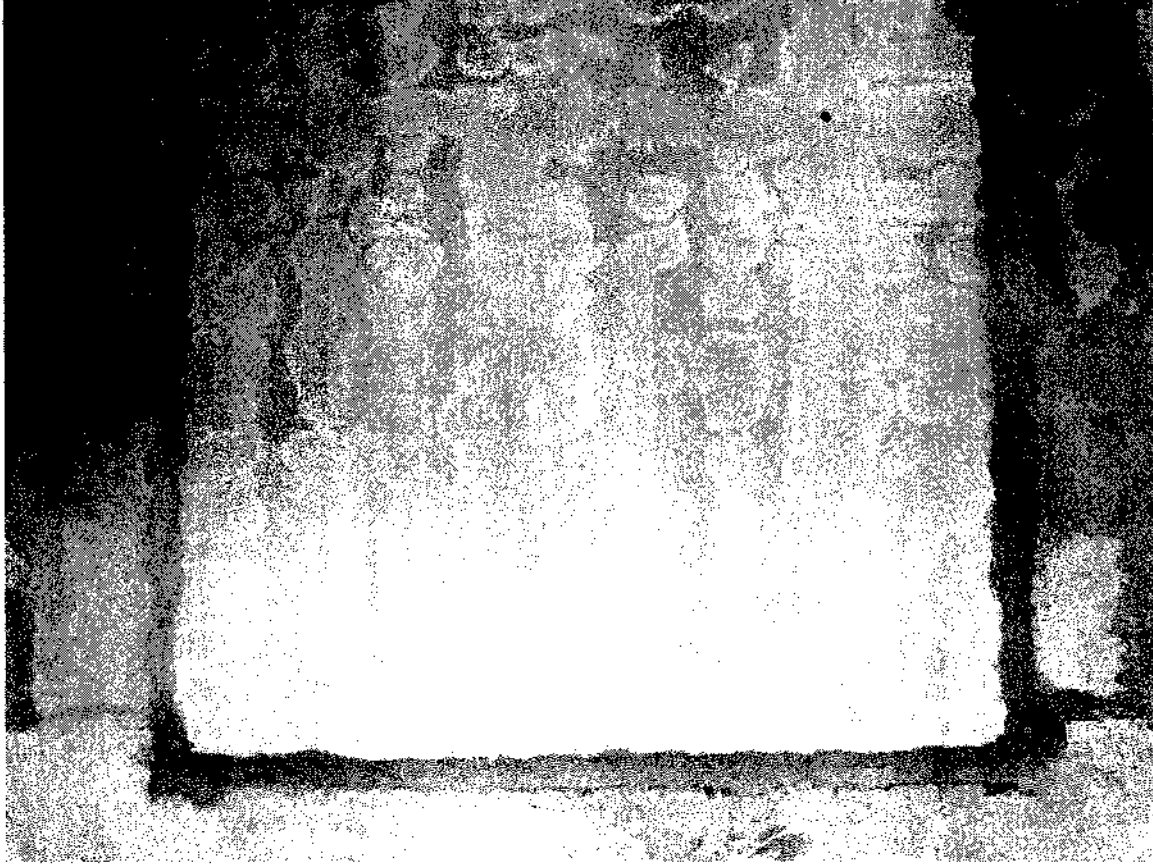
FIGURE 2

EXPOSED SURFACE BEFORE FIRE TEST

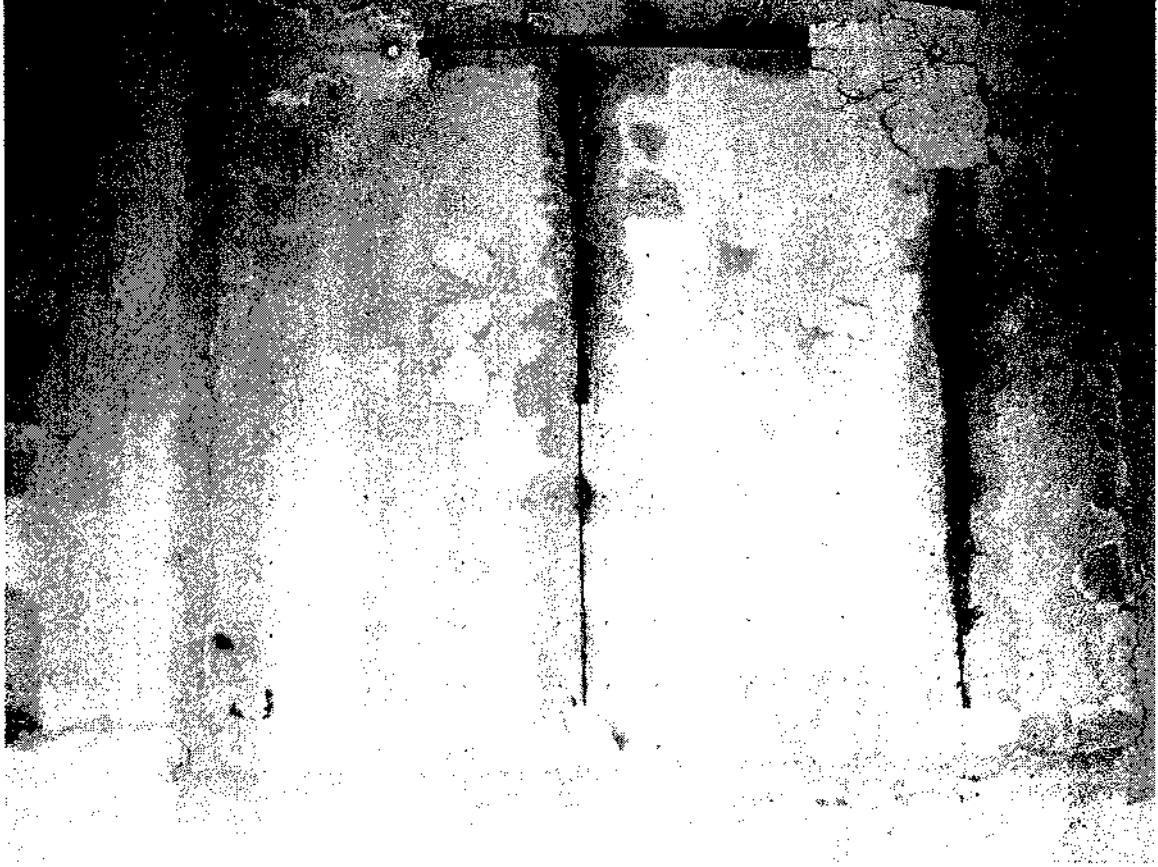
FIGURE 3

TIME (min.)	EXPOSED SIDE
0:00	Start test
1:00	Ignition and charring of paper on gypsum board
5:00	Drywall compound beginning to fall off screw heads
7:30	Larger pieces of compound falling off screw heads
8:30	More compound falling off screw heads and joints
11:30	Slight bulging of wallboard at top/centre of wall
15:00	Gas off

Following the 15 minute fire exposure, the gas was turned off and the test frame removed from the furnace. The gypsum board remained in place and there were no through openings in the gypsum board panels themselves. The majority of the joint compound had fallen off and joints between adjacent panels had separated by approximately 6 mm. See Figures 2 and 3 representing exposed surface of test sample before and after the test respectively.

EXPOSED SURFACE AFTER FIRE TEST
